Final Design and Testing of Blast Mitigating Roller Shutter Door

Phase 2 Summary Report

ABS Consulting Project Number 4456444

Gliderol Doors (S) Pte Ltd

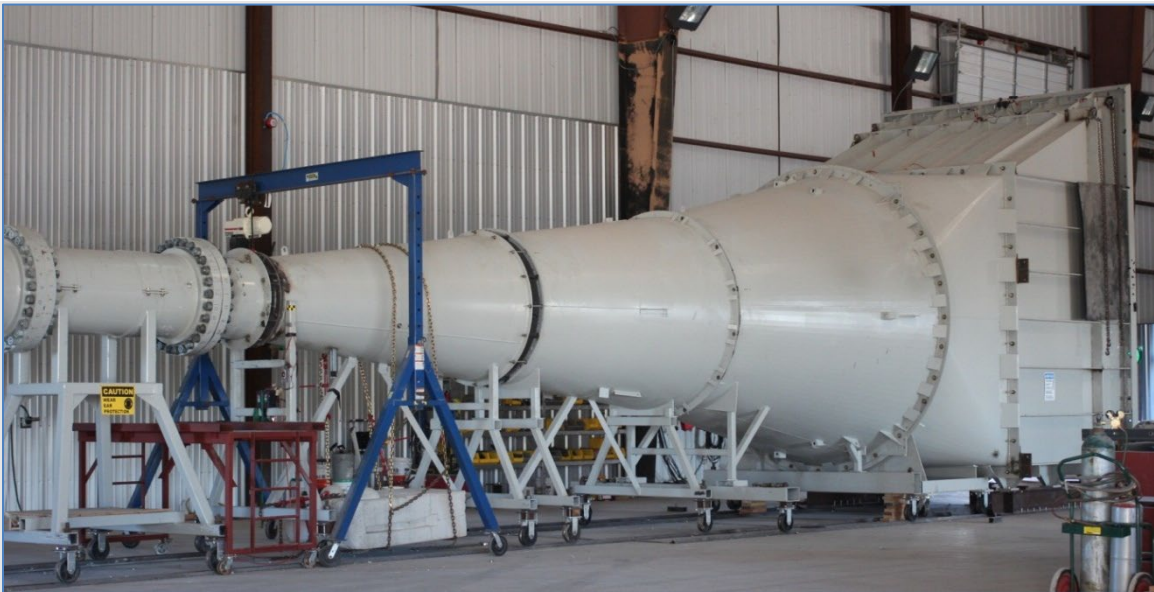
Figure 2. ABS Consulting Shock Tube Apparatus

Blast loads were applied using a “shock tube” as shown in Figure 2. This device uses a sudden burst of compressed air to create a blast pulse, which travels down the tube and is applied to the test specimen which is secured to the end of the tube. The blast load creates a specified positive blast pressure and impulse on the test specimens.

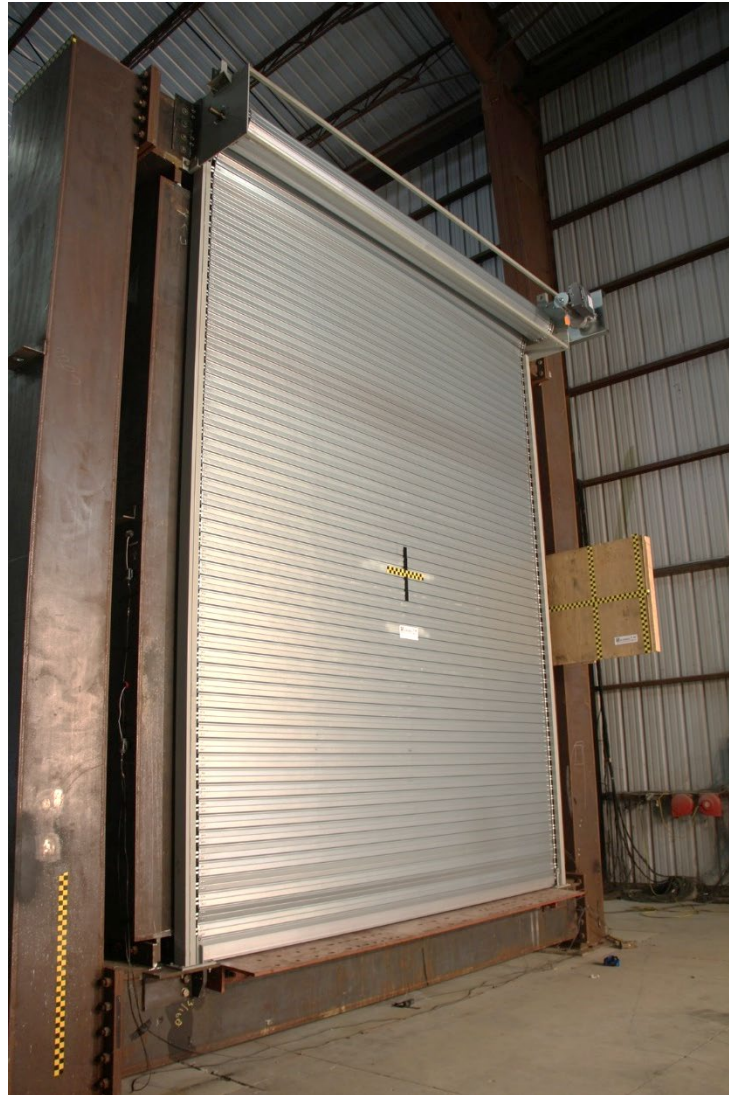
Figure 12. Elevation - PL 1 Configuration

The roller shutter door system tested in the PL-1 configuration is shown in Figure 12 through Figure 17. The shear bolt to restrain the curtain to the baseplate was not included for PL-1 as shown in Figure 15.

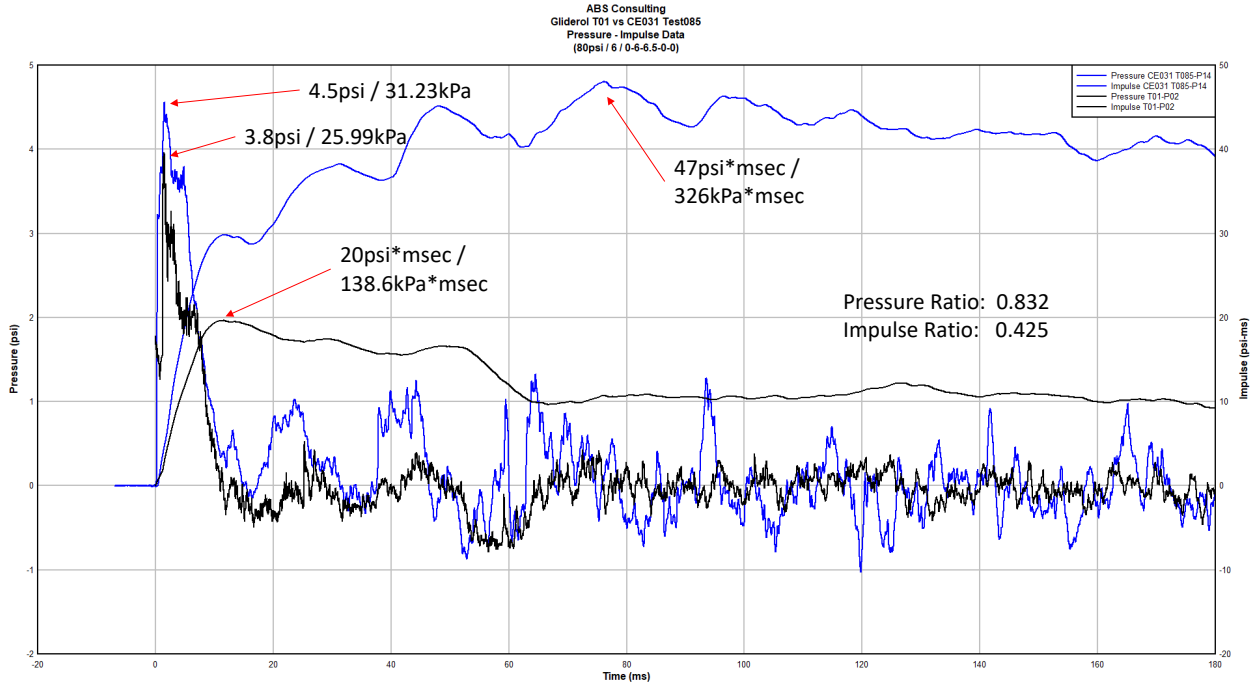
Figure 25. Pressure-Time History – Calibration and Test 01

A pressure-time history for gauges in the calibration test (Test 085) and Test 01 of the Roller Shutter Door system (PL 2 configuration) is shown in Figure 25. Calibration test (Test 086) and Test 04 of the Roller Shutter Door system (PL 1 configuration) is shown in Figure 26.

For the PL 2 configuration in Test 01, the calibration test had an average peak pressure of 4.5 psi (31.2 kPa) and an average applied impulse of 47 psi-ms (326 kPa-ms). For PL 1 configuration in Test 03, the calibration test had an average peak pressure of 10.2 psi (70.3 kPa) and an average applied impulse of 159 psi-ms (1096 kPa-ms).

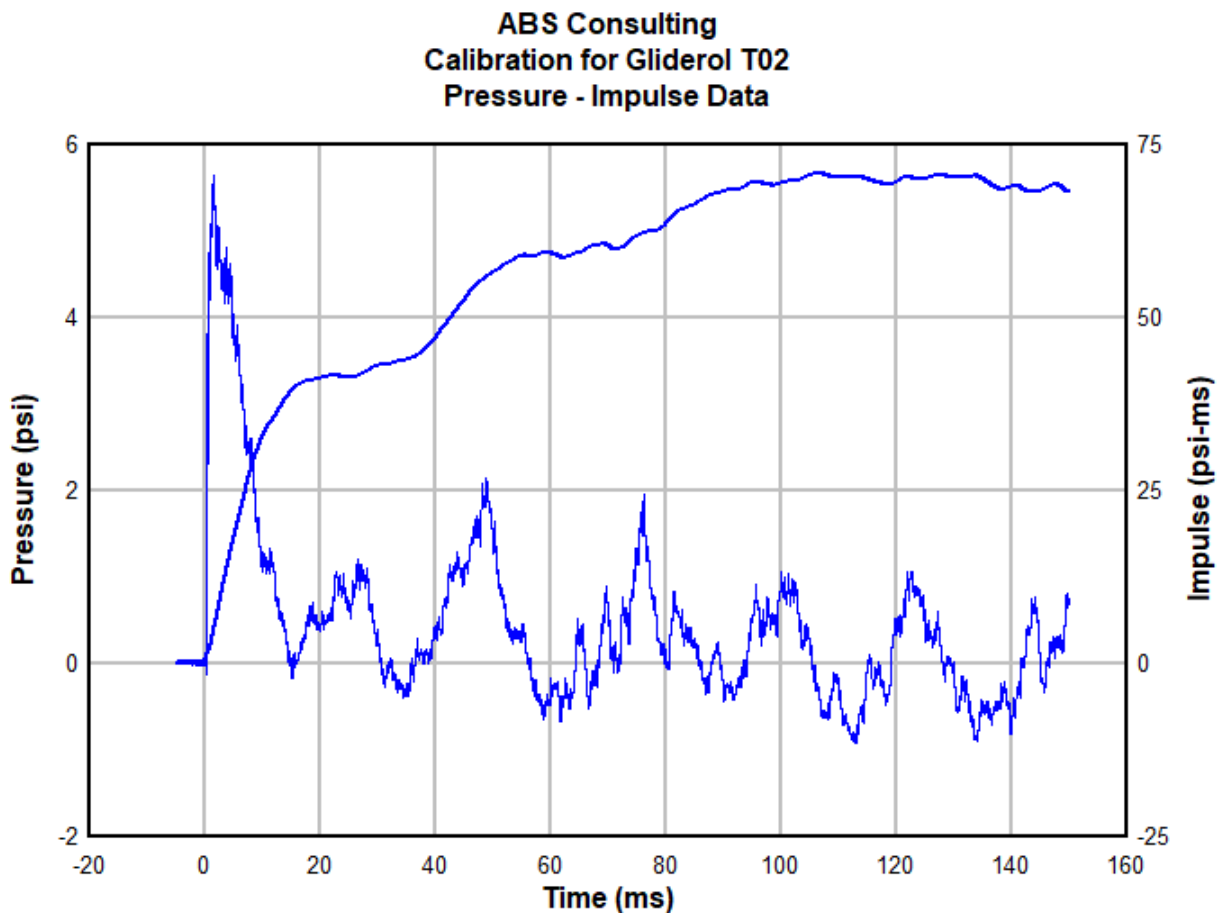
Figure 33. Applied Blast Load Test 02

Test 02 was the second test conducted on the first test article, a PL 2 Configuration. Before the test, the cables and slat rod termination connectors were reinserted into the guide rails, and the drum was rotated to take up slack in the curtain which occurred during the prior test. The applied load was an average pressure of 39.3 kPa (5.7 psi) and an average impulse of 502.6 kPa-ms (72.9 psi-m) based on the calibration test. The pressure-time history is shown in Figure 33. The door curtain deflected uniformly until restrained by the cables and restraining lugs. A maximum deflection of 791 mm (31.2 in) was recorded at 116 ms. The panel was moderately deformed but remained intact. Panel slat and internal rod damage was noted in the lowermost portion of the shutter near the baseplates. The cables were deformed at the shoe due to bearing on the shear bolts, but no failures were noted. There was no damage to the drum or supports. The door curtain extended approximately 101 mm downward due to rotation of the drum. No failures of the door system or support framing were noted post-test.

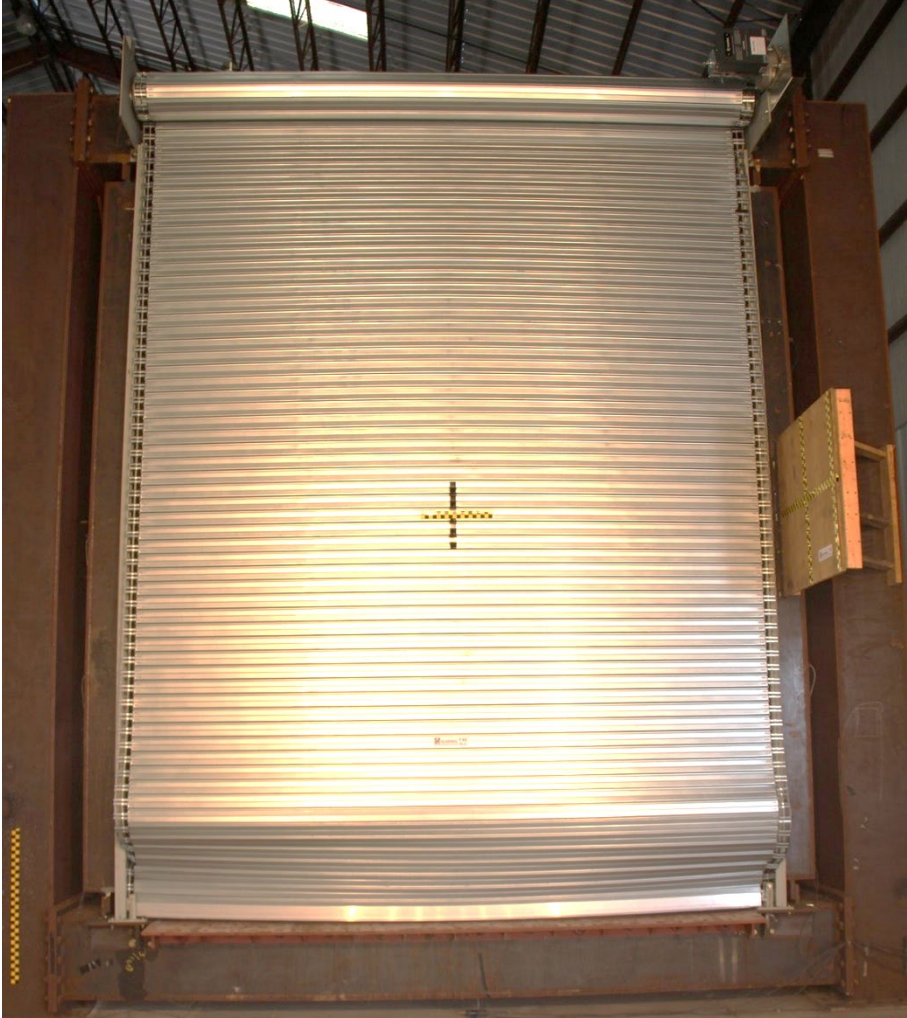
Figure 34. Test 02 - Post-Test Photo of Test Article

An overall view of the post-test condition of this test article is shown in Figure 34. A close-up of the condition of both sides of the panels is shown in Figure 35. Figure 36 shows the curtain shoe and restraining system. A side view of the door panel deflection taken from the high-speed video is shown in Figure 37.

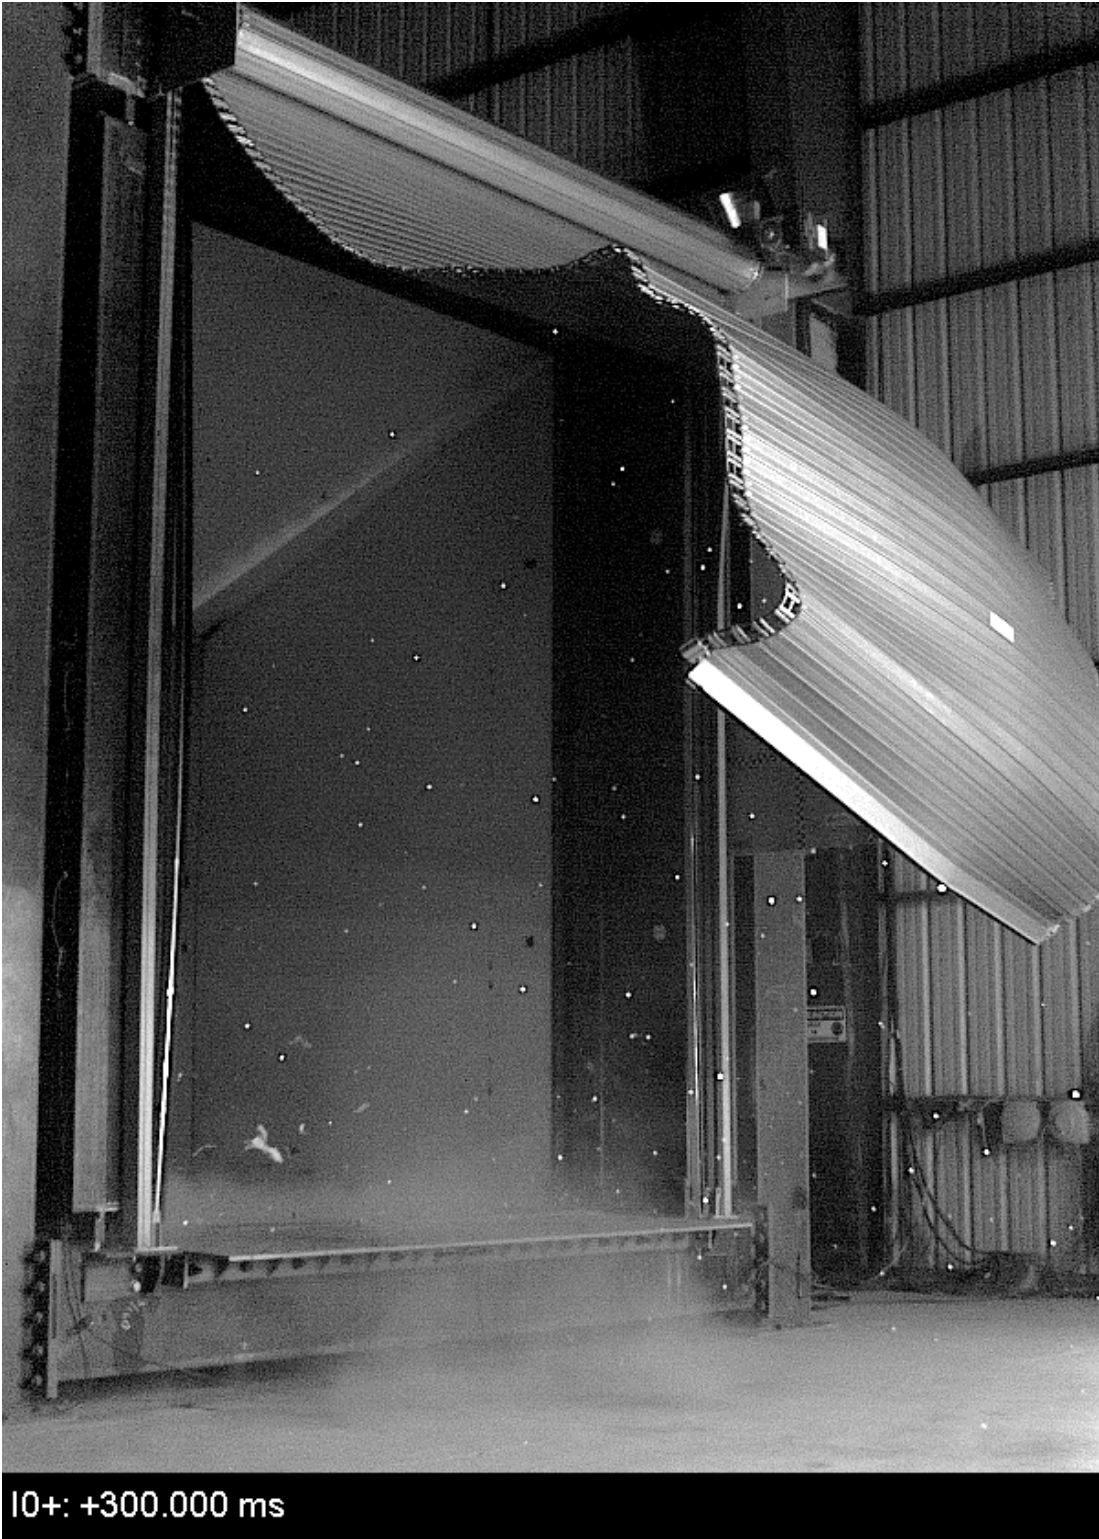
Figure 42: Test 03 - Image from High-Speed Video

An overall view of the post-test condition of the article is shown in Figure 39. A close-up of the condition of both sides of the panels is shown in Figure 40. The curtain bottom is shown in Figure 41. An image at 300 ms, taken from the high-speed camera footage of the curtain rotating upwards, is shown in Figure 42.

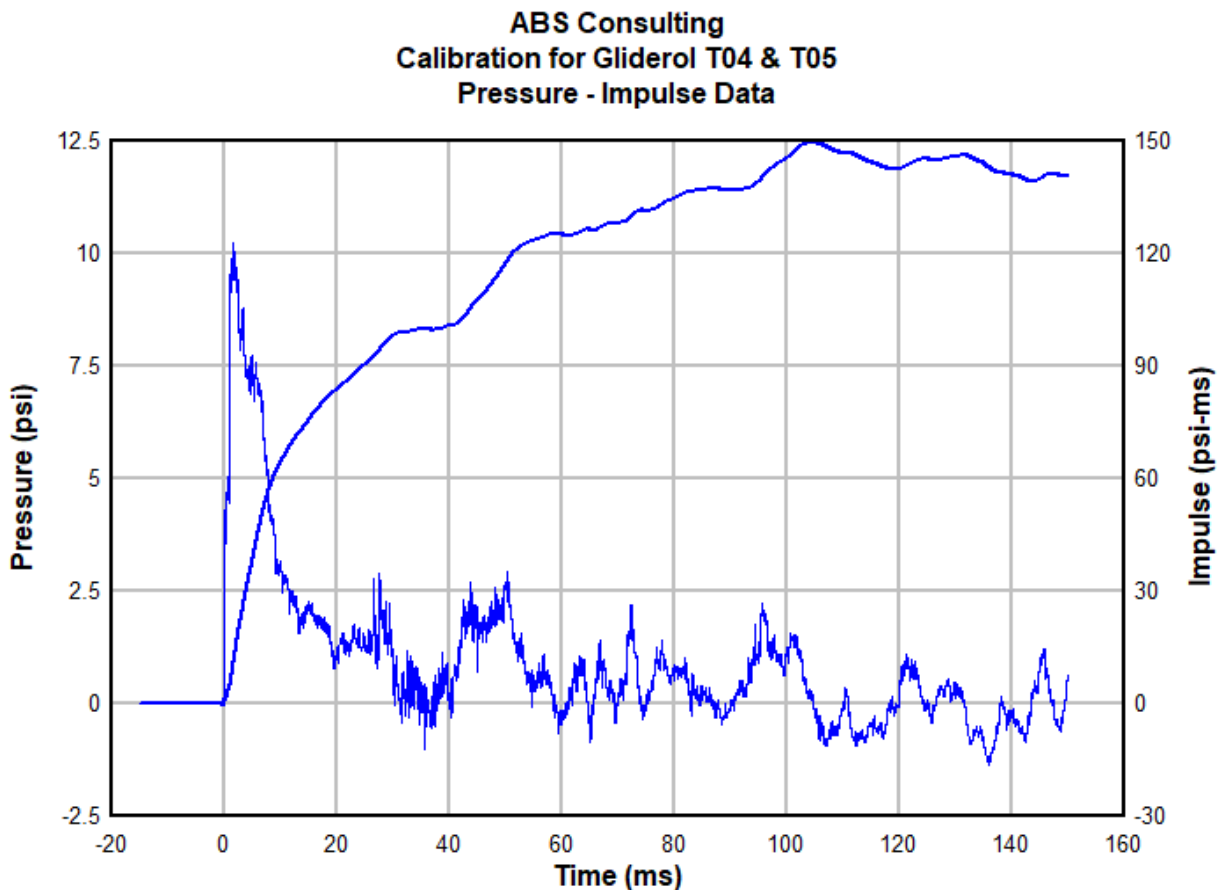
Figure 48. Applied Blast Load Test 05

Test 05 was the second test conducted on the second test article. A PL 2 configuration was used. The applied load was an average pressure of 10.9 psi (75.2 kPa) and an average impulse of 151.8 psi-ms (1046.6 kPa-ms) based on the calibration test shown in Figure 48. This impulse was 350% of the design load for the PL 2 configuration. The door curtain deflected uniformly until restrained by the cables and restraining lugs. A deflection of 461 mm (18.1 in) was recorded at 100 ms at which point the restraining lug on the left side failed at the weld connection to the base plate on the left side. The restraining lug on the right side did not fail. The door curtain continued to deform with a maximum deflection of approximately 2000 mm. The panel was moderately deformed. The drum rotated until all the remaining door curtain unrolled. No damage to the cables or door panels was observed at the drum. The drum axle sheared at the end plate at approximately 48 ms, allowing the drum to unwind. The drum was still supported by the plate and bearing. No debris from the door or hardware was projected.

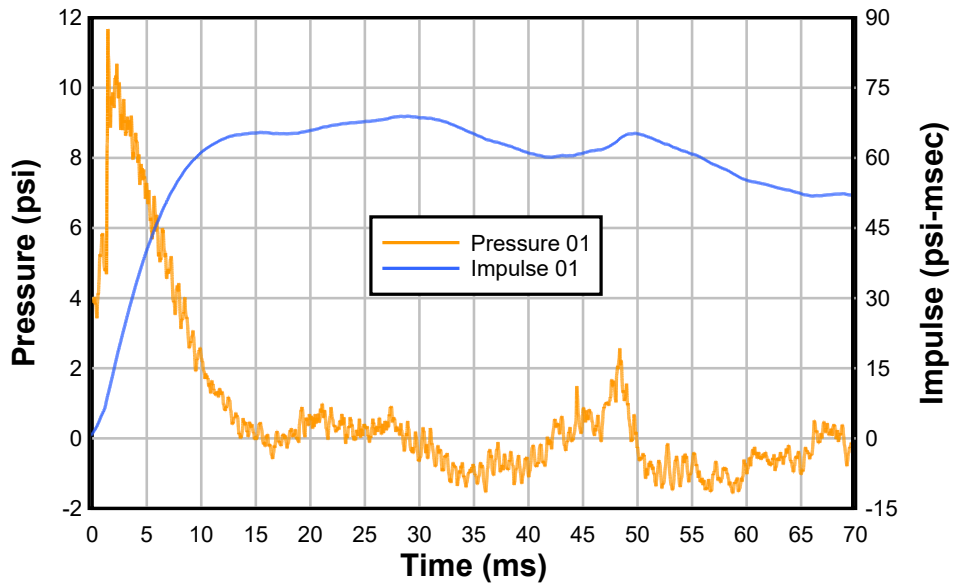
Figure 56 Test 04 Applied Blast Load (Includes Leakage)

Results are presented below in Figure 56 through Figure 61. Midspan displacement of the roller shutter door panel was approximately 1830 mm at approximately 160 ms. Additionally, the axial force developed in the cable had a peak magnitude of approximately 8.7 kN at approximately 50 ms. Response of the door panel was similar in form to the pretest load analysis. The door panel velocity at the midspan was lower for the test load than for the design load. This is to be expected since the test impulse was on the order of 55% less due to leakage of the blast load.
